Name of Dam: Bernhart Dam

County and State: Berks County, Pennsylvania

Inventory Number: PA 00717

PHASE I. INSPECTION REPORT

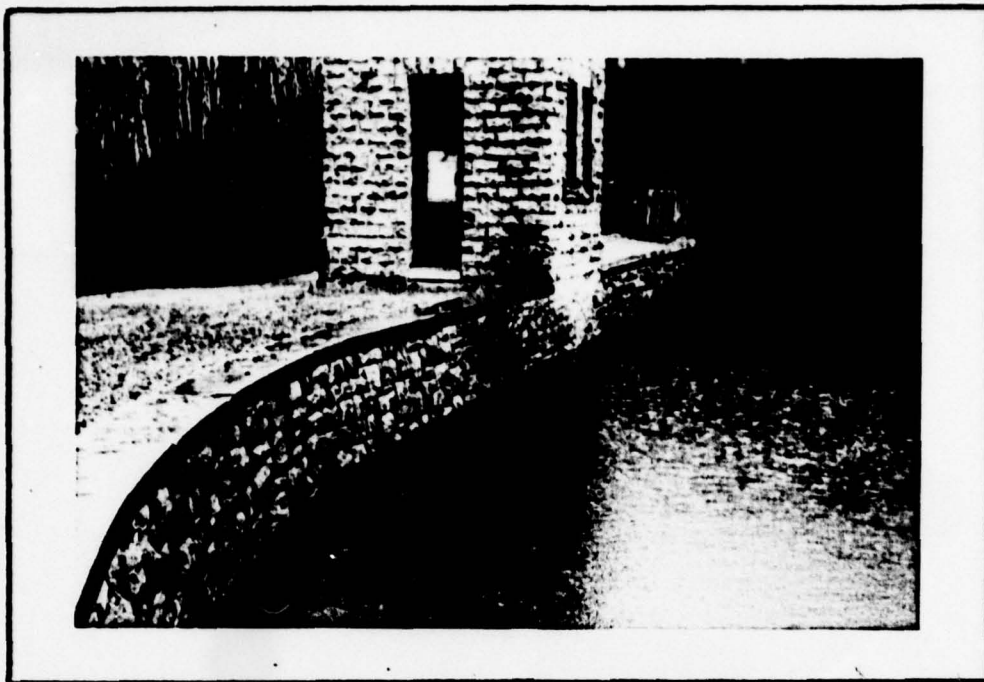
- a. Visual Observations. The small trees growing out of cracks in the upstream face of the masonry wall create potential seepage paths through the embankment. The point at which the trees protrude from the wall is about 2 feet above normal pool, so during periods of high reservoir level, water could seep through the cracks and along the root systems.

*UPSTREAM FACE OF THE DAM SHOWING THE GATE HOUSE
AND THE VEGETATION GROWING FROM THE MASONRY WALL*

5. The eroded path along the embankment and spillway junction should be filled with compacted earth and reseeded.
6. The small trees should be removed from the upstream face of the masonry wall and the cracks from which they were growing should be sealed.
7. The spillway for the upstream settling basin should be repaired so that it functions as designed.

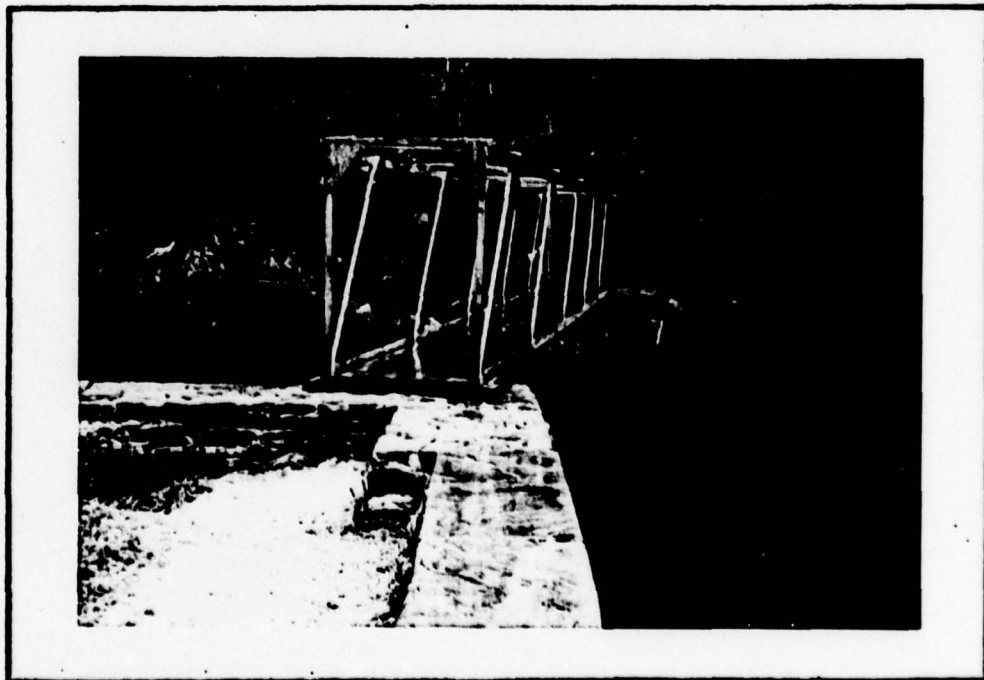
The eroded path along the embankment and spillway junction creates a natural seepage path for surface runoff. Continued erosion could lead to possible damage to the embankment and spillway training wall.

*VIEW SHOWING THE FOOT BRIDGE OVER THE SPILLWAY
AND THE LACK OF VEGETATION ON PORTIONS OF THE DAM*

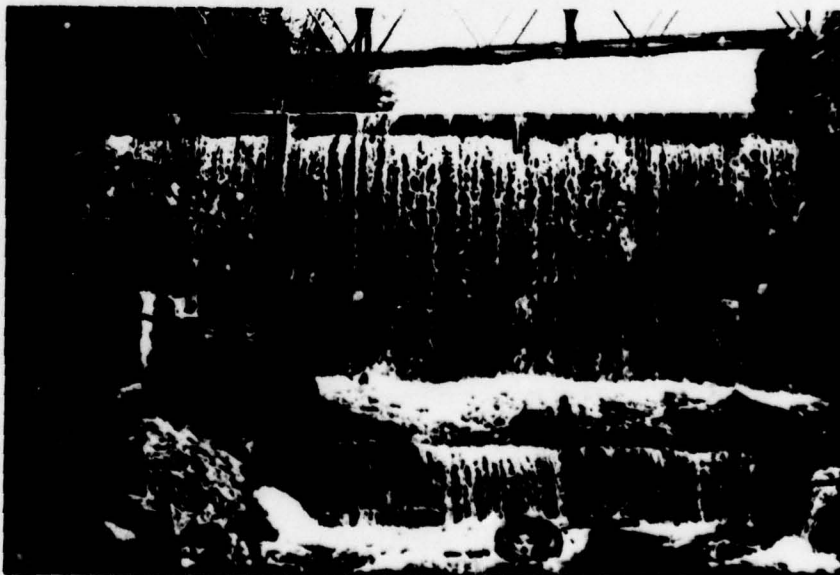
- c. Appurtenant Structures. The spillway vertical drop is approximately 15 feet and the drop section appears to be in good condition. A metal truss and wood deck bridge spans the spillway with a minimum clearance of 5 feet between the spillway crest and the bottom of the bridge.

*VIEW SHOWING THE FOOT BRIDGE, DROP SPILLWAY,
AND DOWNSTREAM APRON*

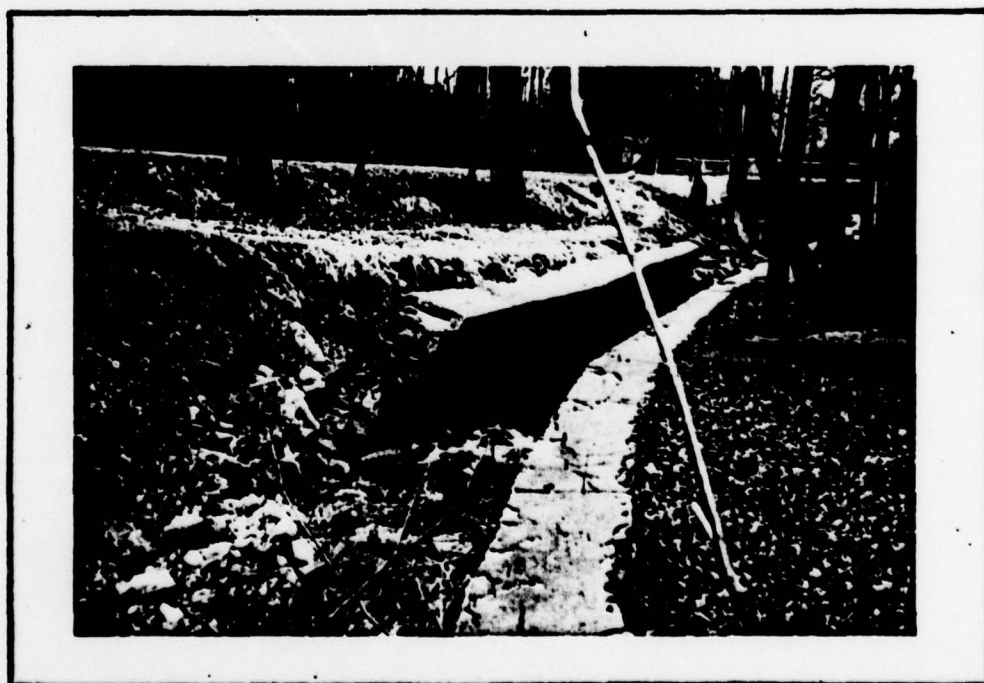
- e. Downstream Channel. The left training wall of the channel downstream of the spillway is in dilapidated condition. Approximately 150 feet downstream of the spillway, the wall has crumbled and a 30-foot long section has toppled into the channel. Portions of the wall have completely disintegrated and both training walls have been undermined in places where they are still standing.

*LOOKING DOWNSTREAM AT THE CRUMBLed AND DISPLACED
LEFT TRAINING WALL IN THE SPILLWAY OUTLET CHANNEL*

THE TRAINING WALLS
SHOULD BE REPAIRED,
RECONSTRUCTED, AND
REPLACED WHERE
NECESSARY.

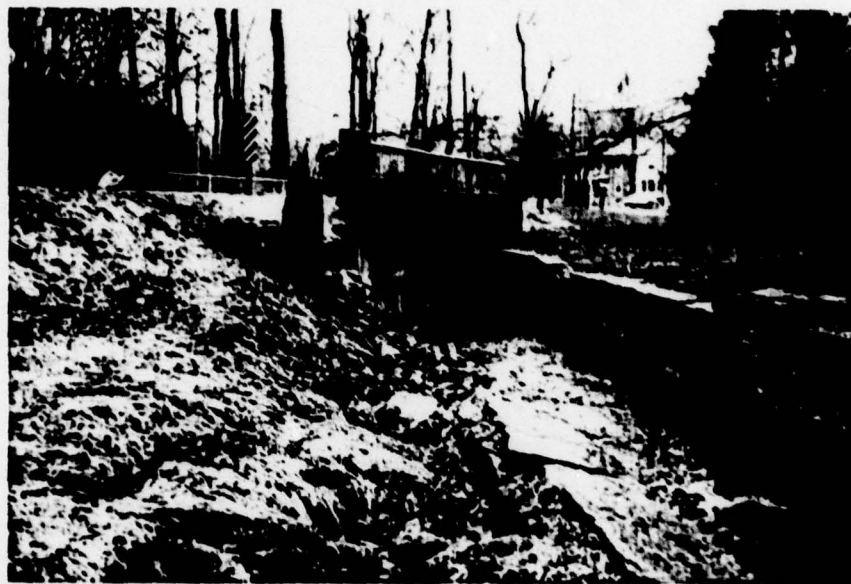
*SPILLWAY OUTLET CHANNEL LOOKING DOWNSTREAM
TOWARDS THE BRIDGE SECTION WHICH IS ABOUT
400 FEET DOWNSTREAM OF THE DAM*

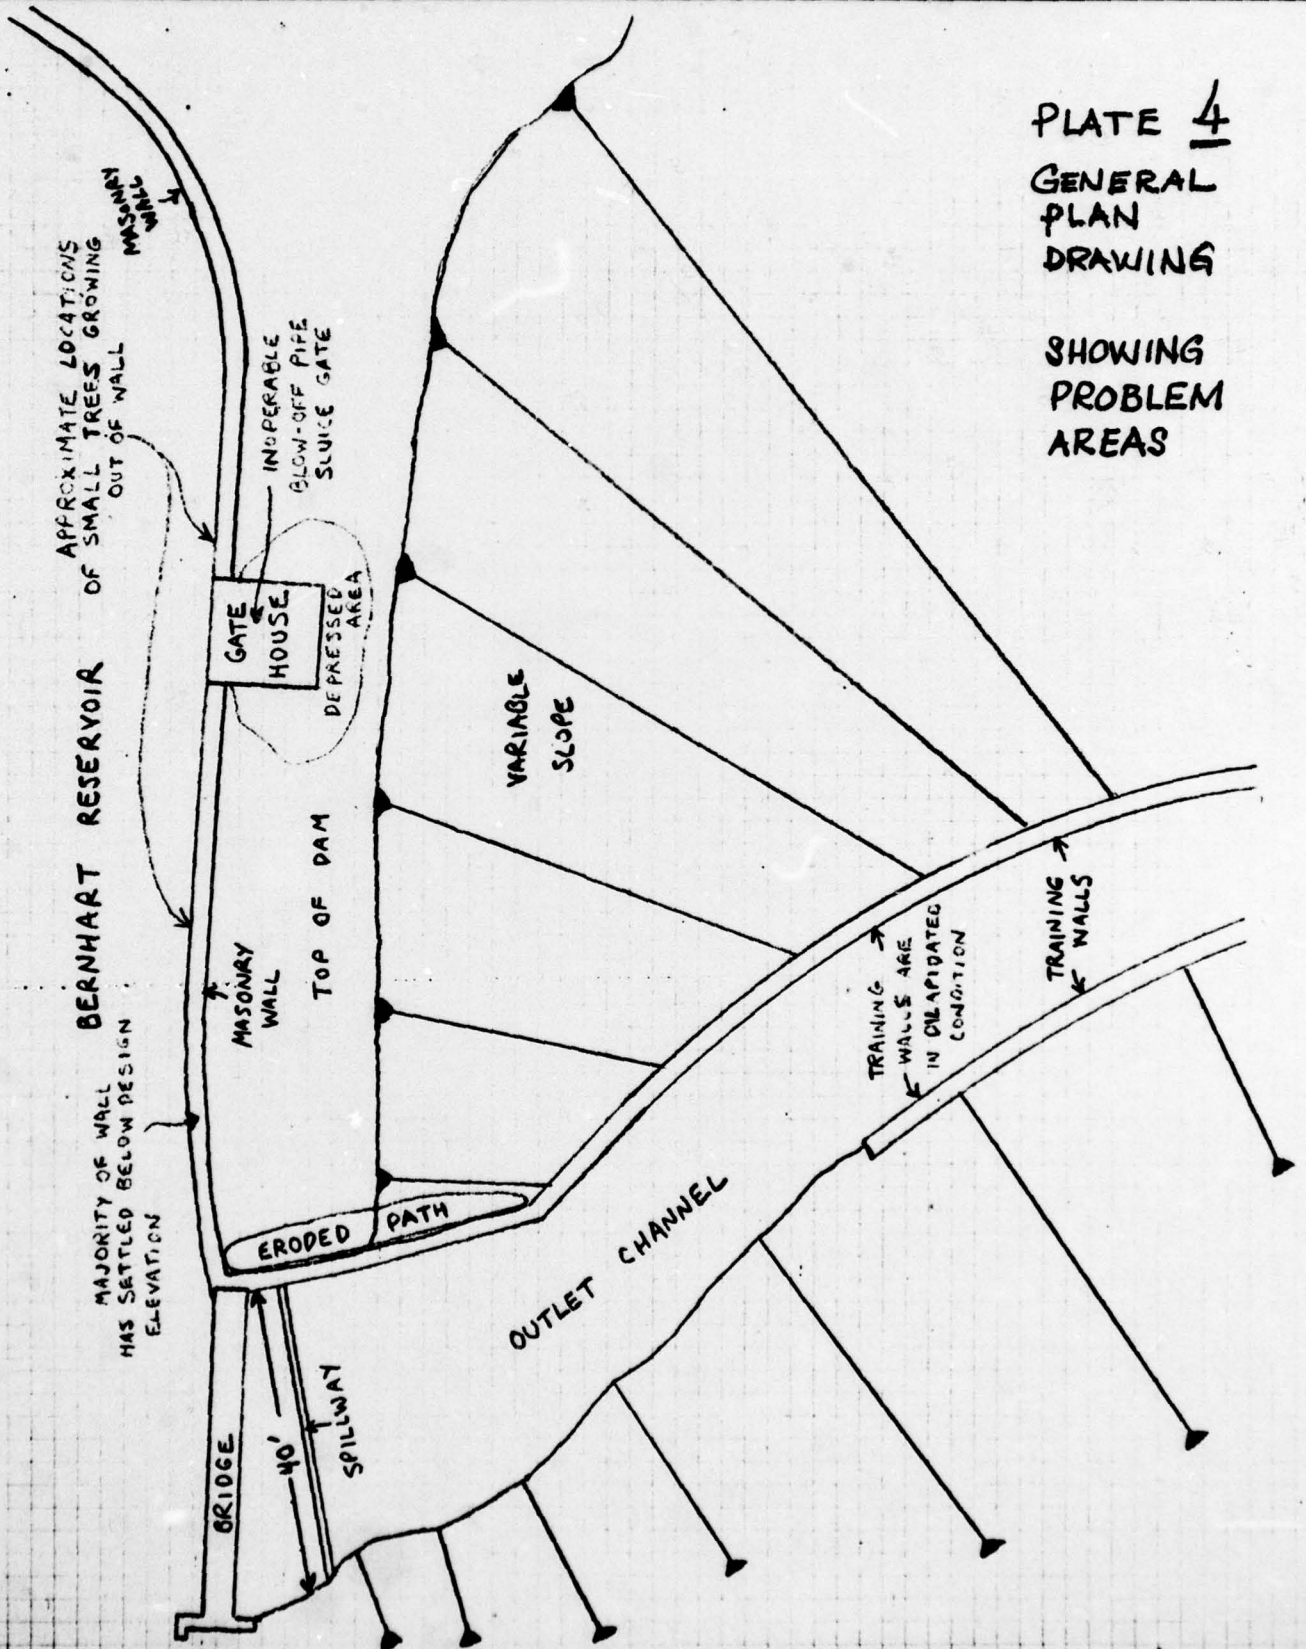
PLATE 4
GENERAL
PLAN
DRAWING

SHOWING
PROBLEM
AREAS
